## SERVICE BULLETIN

Service Bulletin Number: SB-002

Subject: **HIGH PRESSURE Fuel Pump Replacement.**

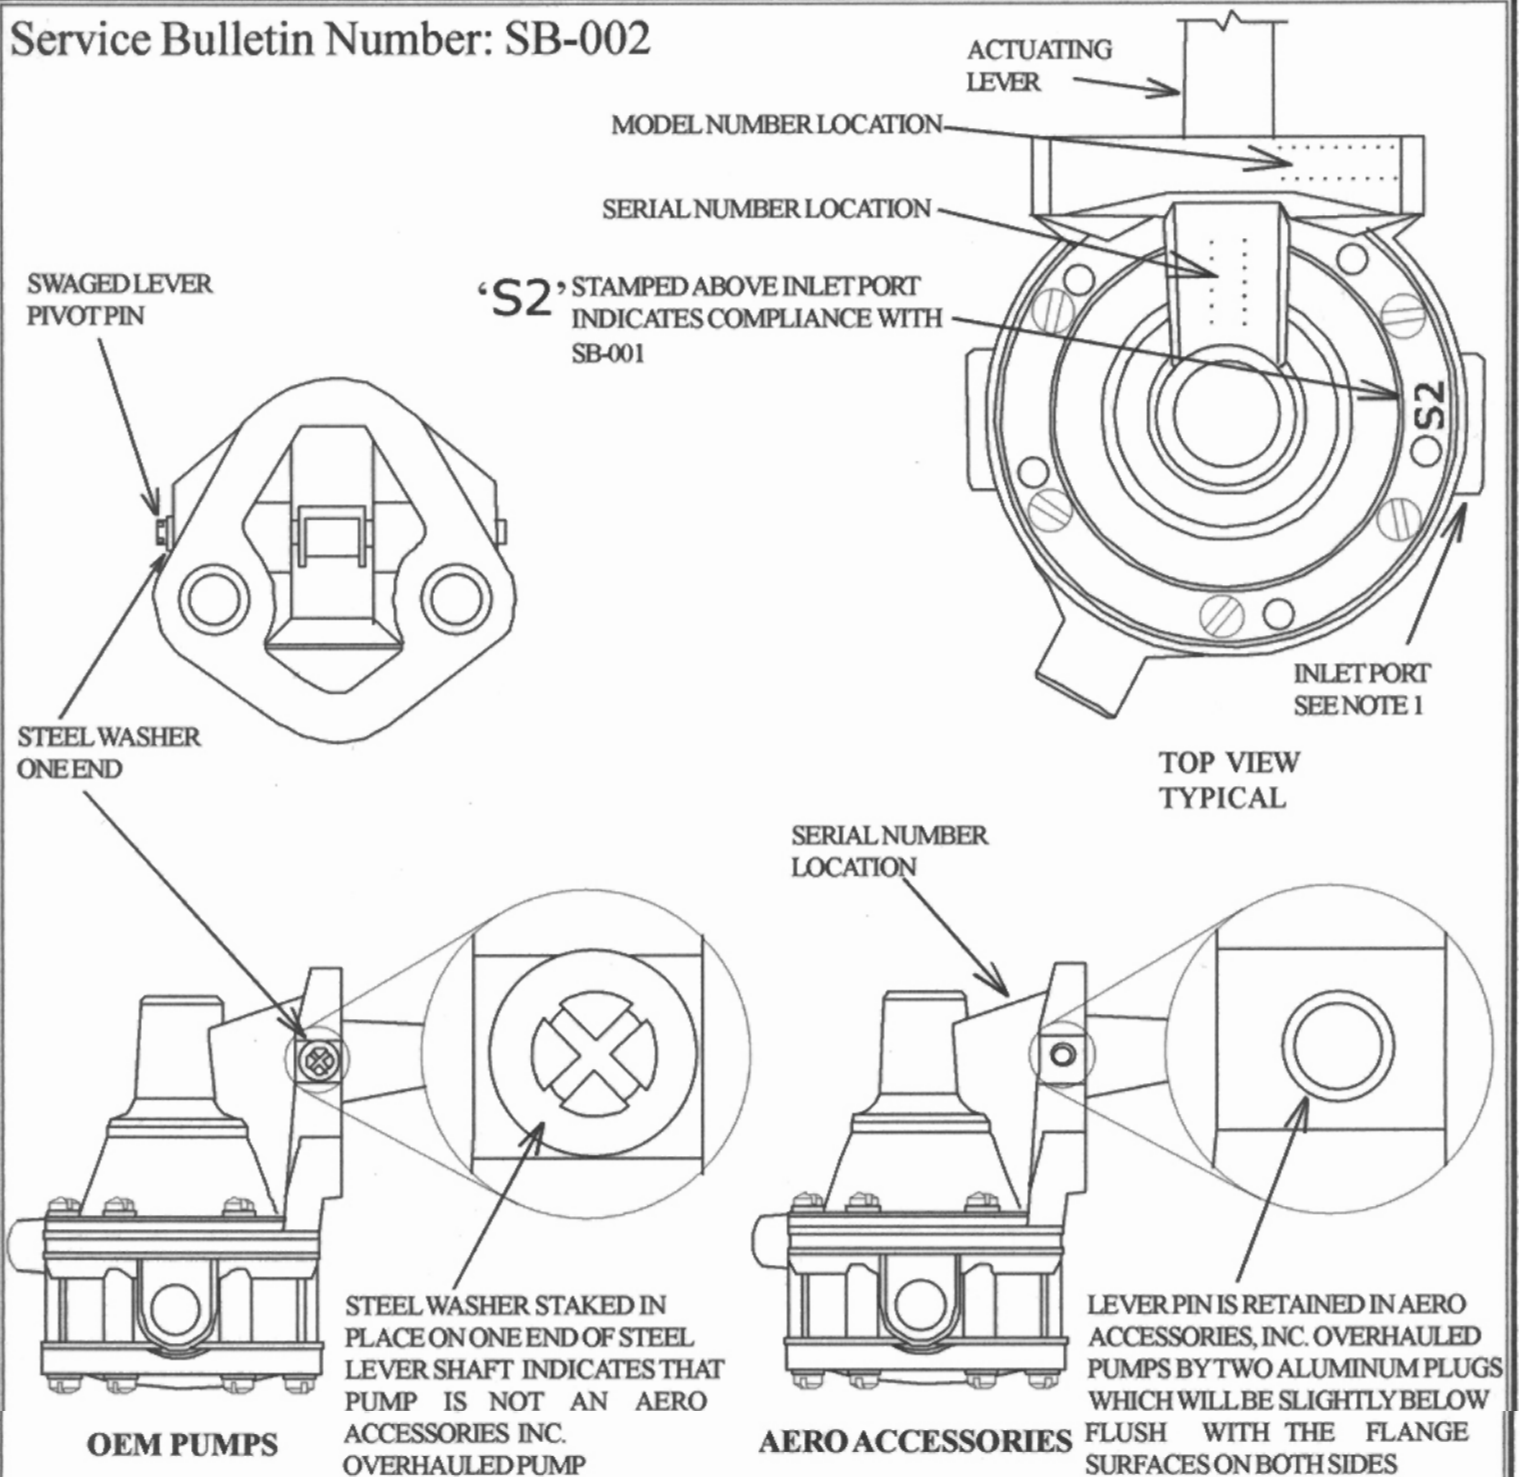
Affected units listed above which are in compliance with Service Bulletin SB-002 will be identified by the characters 'S2' stamped as indicated on Page 2 of this Service Bulletin.

1. Port locations vary on some model pumps.
2. Some OEM units may use the Aluminum Pin Retaining System also, therefore, before removing a pump, verify that the Serial Number is on the affected list. Aero Accessories, Inc. has never used the steel washer system.
